Inspection Report

Permit Number:	C0070039
Inspection Type:	PARTIAL
Inspection Date:	Wednesday, September 24, 2008
Start Date/Time:	9/24/2008 12:00:00 PM
End Date/Time:	9/24/2008 4:00:00 PM
Last Inspection:	Tuesday, August 26, 2008

InspectionID Report Number: 1780

Site: **DUGOUT CANYON MINE**

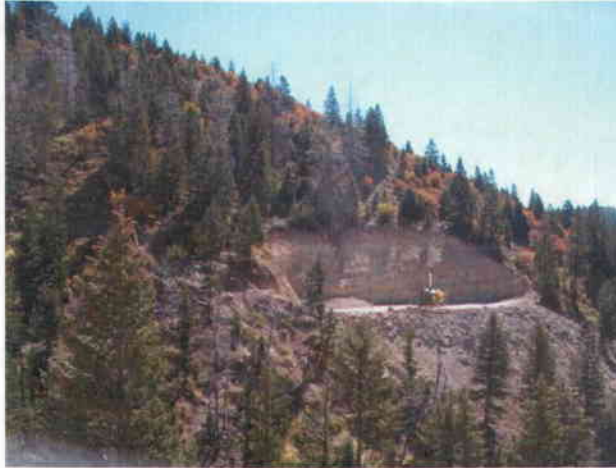
Gas Wells GW-18, GW-19 and GW-31 were photographed. GW-19 is east of the AMV road as shown on Attachment 5-4, Plate 1. GW-31 is no longer active and may be reclaimed next season. Two mudpits at GW-31 still contain water.

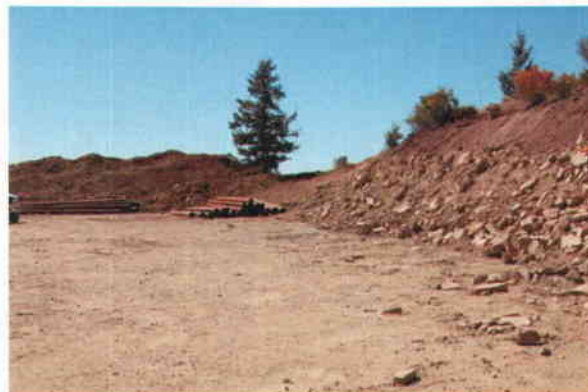
The total disturbed acreage for degas wells #18, #31 and AMV road is 19.29 acres. The AMV road is 6,705 ft. long. An average of one foot of topsoil was removed from all disturbed areas (Attach. 5-4, As-Built Areas and Cut/Fill Volumetrics). Visual characteristics of the topsoil confirms topsoil texture analysis and rockiness detailed in Attachment 2-1 of the Methane Degas Volume. Along the AMV road, salvage of soil to the one foot depth included both topsoil and the whitish subsoil. Topsoil stockpiles at the pads is reddish clay loam. Extremely rocky topsoil and subsoil was noted at degas pad G-18.

GW-18
(topsoil pile T-10 in background)

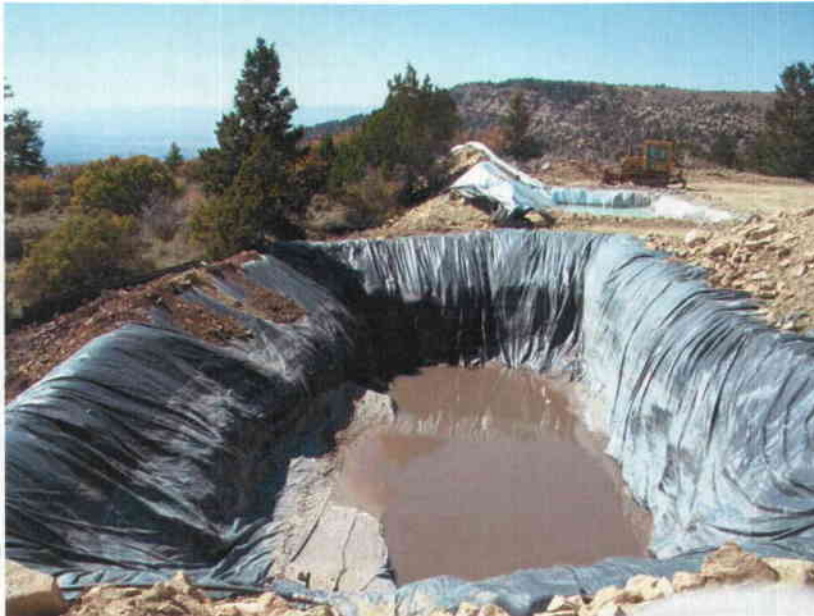
mud pits at GW-31

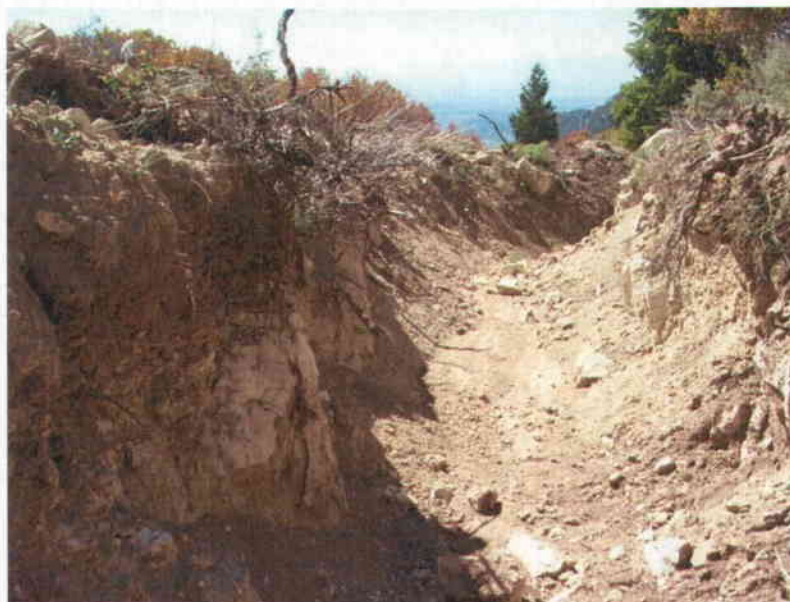
The berm around stockpile T-6 is made of topsoil, not subsoil. Berms around several topsoil piles were excavated from around the topsoil pile, so that the piles have moats (T-7, T-10, T-5). As discussed with Ms. Miller, this approach should be avoided in the future.

excavated "moat" around T-7

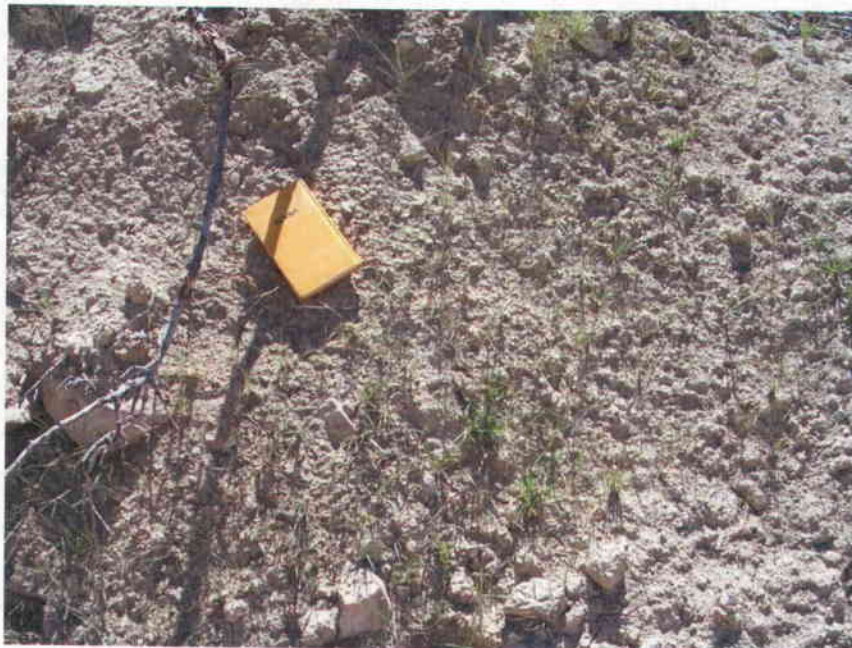
Eight topsoil stockpiles were constructed along the road and at well pads in the late fall 2007. Table 2-2 provides stockpile dimensions derived from aerial photography. Stockpiles were roughened and seeded immediately after construction. Some grass seedlings and several snowberry seedlings have emerged on most stockpiles.

Emerging grasses on T-7

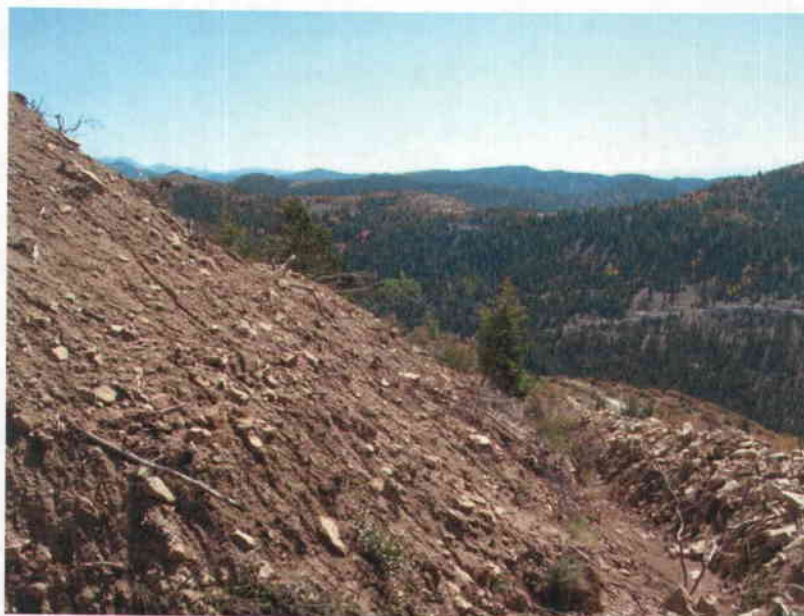
Topsoil stockpiles appear to be at the angle of repose, and steep outcrops have lost their surface roughening through slope movement on the following piles: T-5, T-6, T-7, T-9, and T-10. After the site visit, topsoil pile slope angles were calculated from information provided in Attach. 5-4 Plate 3 as follows: T-5, T-6, and T-7 are quite steep (1.5h:1v, 1.6h:1v, and 1.8h:1v, respectively). Stockpiles T-2, T-3, and T-10 have lesser slopes of 2h:1v or less.

Gouges "melted" on slope of T-9

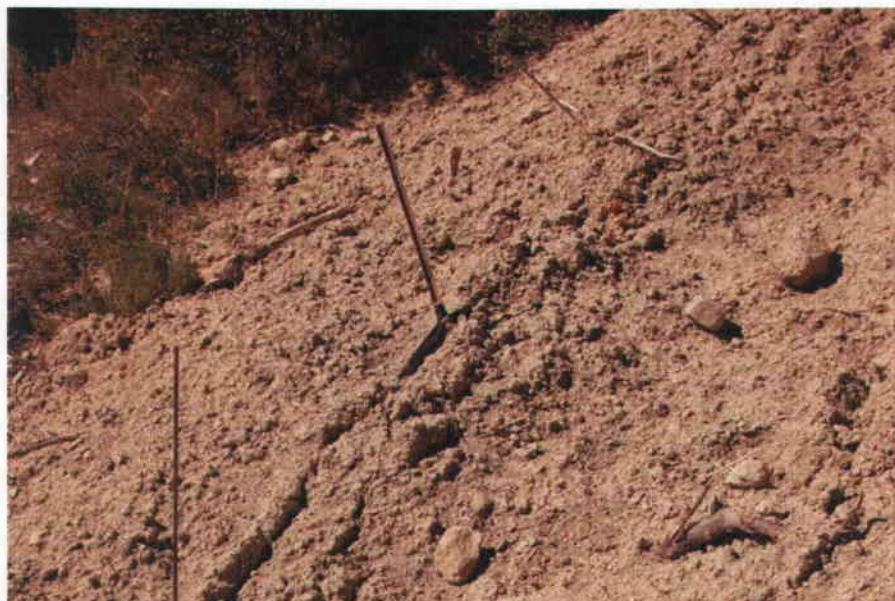
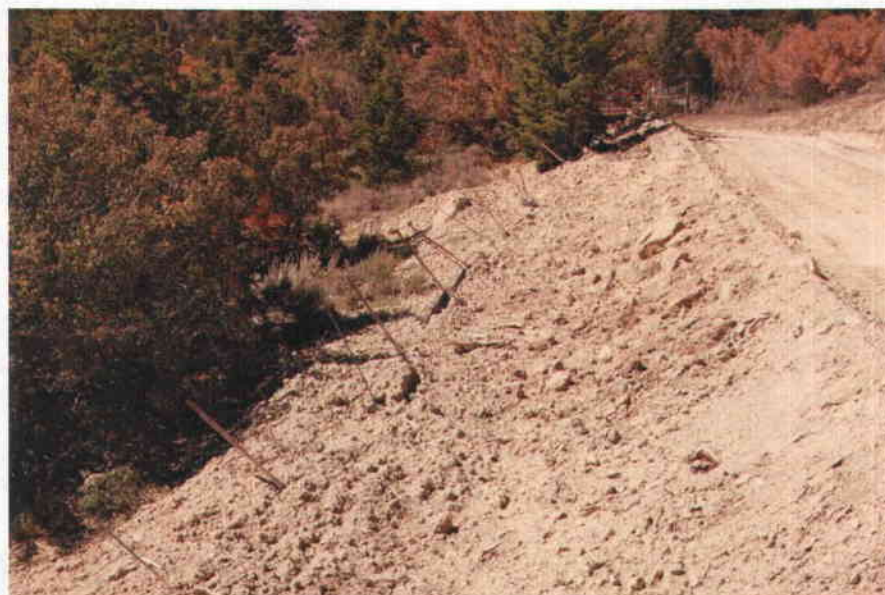
On page 7-16 of the approved methane degas well amendment to the MRP, the Permittee states that additional contributions of sediment or runoff outside the wellsite areas, as well as the access roads, will be prevented to the extent possible by utilizing silt fences, berms and straw bale dikes. Upon inspection of the AMV access road, the Permittee opted to use silt fences at the out slopes of the access road, as well as along the perimeter of the pads for degas wells G-18 and G-31. Although large segments of the access road's silt fence was functioning as designed and was observed to have additional sediment holding capacity, there were several areas observed during the field inspection where the constructed silt fence was either entirely buried or had already failed allowing sediment to be transported off the disturbed area (See Attached Photos).

Areas where the silt fence was noticeably impacted and failing was observed in numerous areas: 1) Directly adjacent to degas pad G-31 on the east side. 2) Up and down gradient of culvert C5. 3) Up and down gradient of culvert C4 and 4) The approximately 900' of AMV access road between culvert C4 and topsoil pile T-3. The aforementioned locations are general examples of where the sediment controls require maintenance. It is not intended as a comprehensive list.

Silt Fence Failure Example (Adjacent to G-31)

On September 30th, 2008, Ms. Miller and Mr. Christensen discussed the approved sediment control language within the approved methane degas amendment to the MRP. Mr. Christensen pointed out that according Section 742.200 on page 7-16, "Additional contributions of suspended solids and sediment or runoff outside the well site area, including access roads, will be prevented to the extent possible using silt fences, berms and straw bale dikes." Due to the observed failure of the silt fence in numerous locations adjacent to the AMV access road and degas pads, Ms. Miller indicated that additional silt fence would be installed in order to provide adequate sediment control. Ms. Miller indicated that the additional sediment controls would be installed prior to the onset of winter and inaccessible conditions due to snowfall.

On October 14, 2008, Ms. Miller indicated to Mr. Christensen via a phone conversation that additional silt fence had been ordered and that the additional silt fence would be installed prior to be driven off the mountain due to weather conditions.

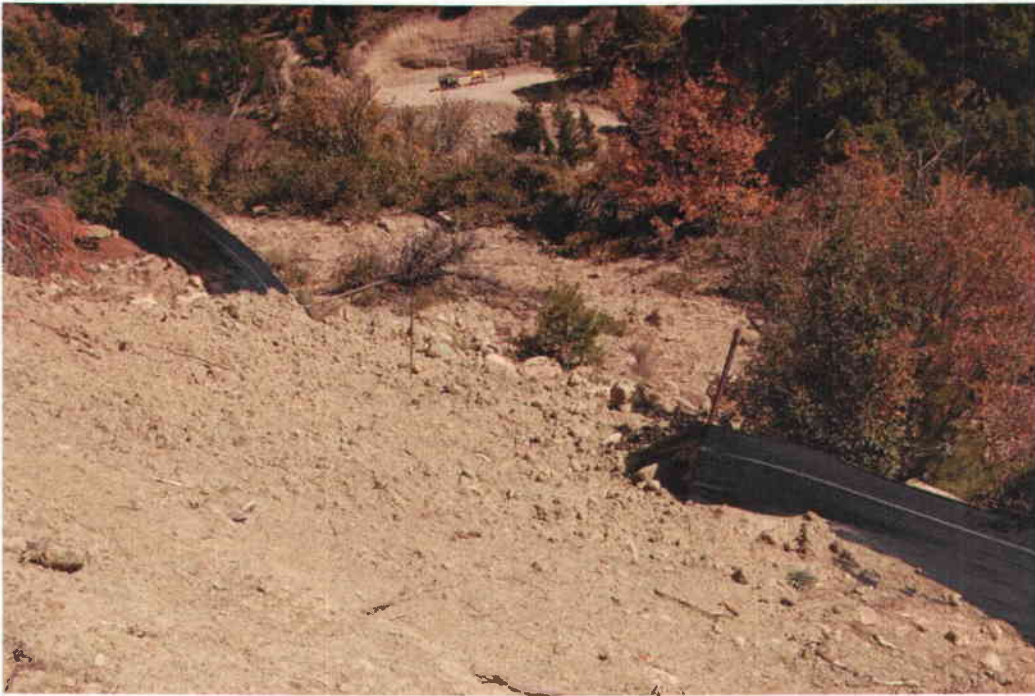
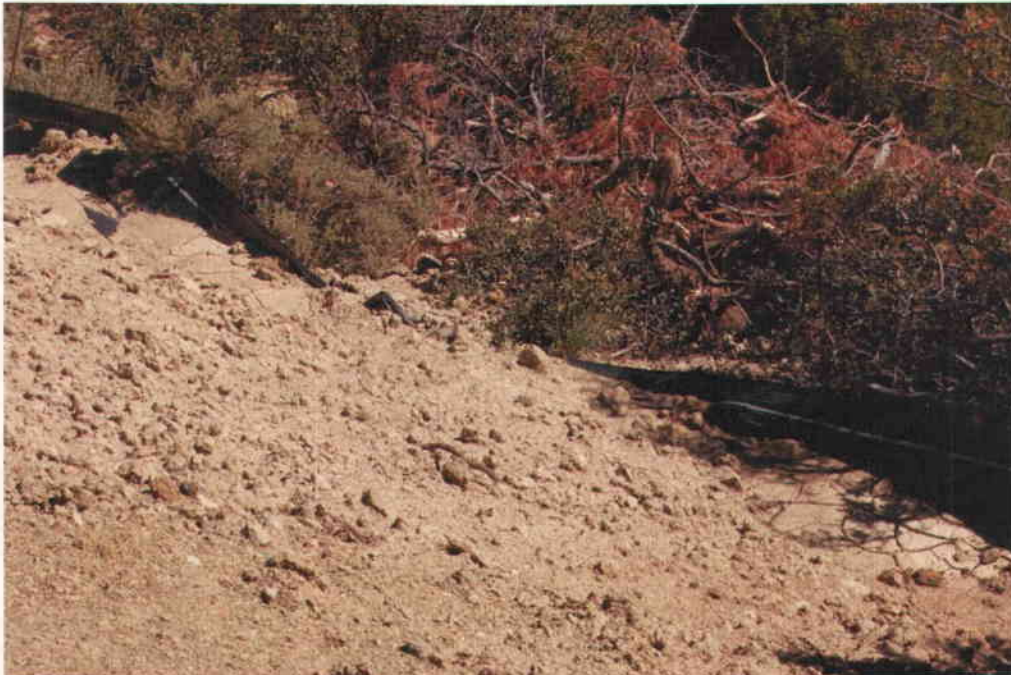
Silt Fence Failure Example
